# Anderson Materials Evaluation, Inc.

DATE 24 March 2024

SUBJ Analysis of MS International, Inc. Cementino Gray Matte Porcelain Floor Tile Samples Described as Good (Lot 230710) and Bad (Lot 230709) using 3D Optical Microscopy, Profilometry, and Laser-Induced Breakdown Spectroscopy (LIBS)

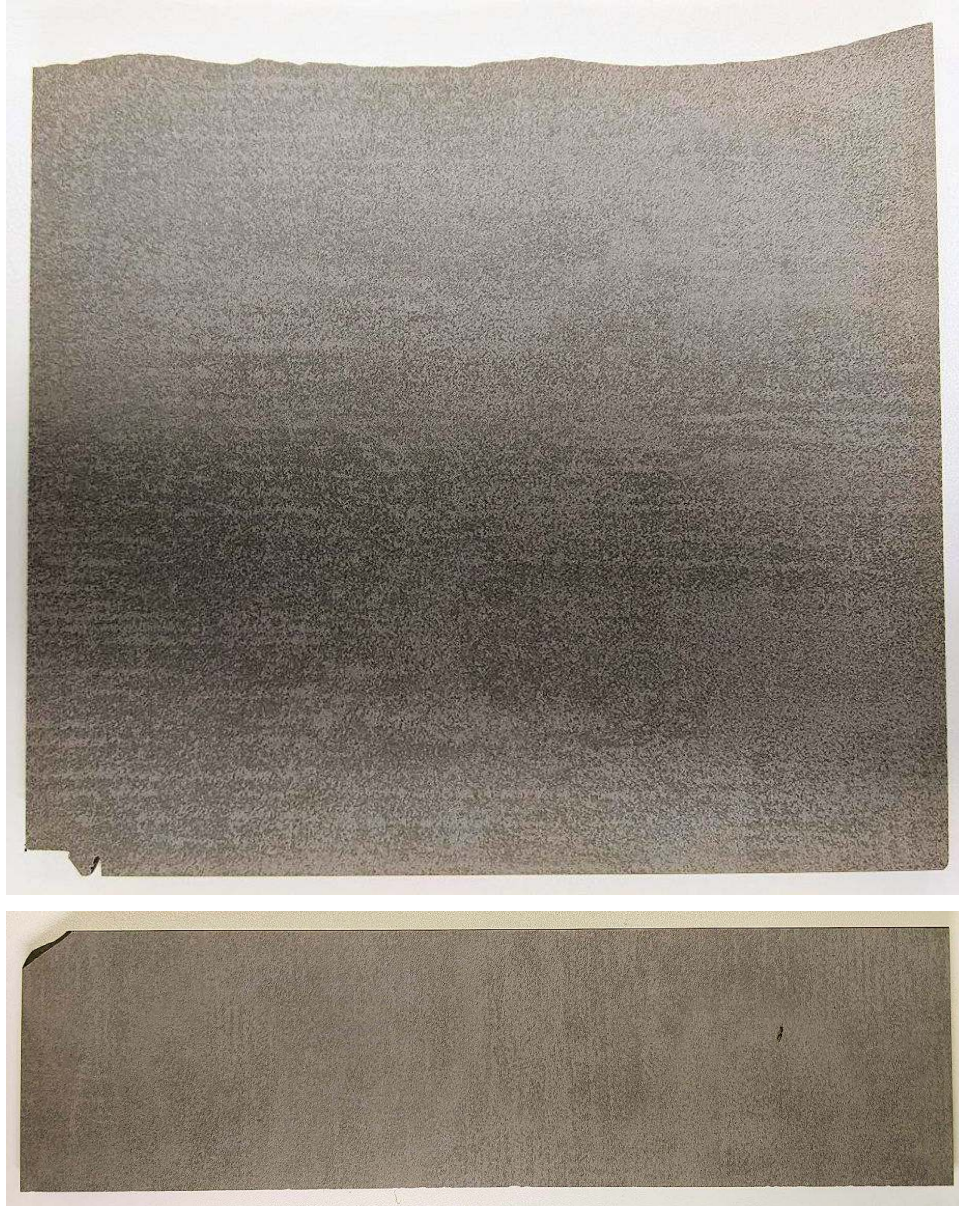
Figure 1. The Bad tile is shown above and the Good tile is shown below.

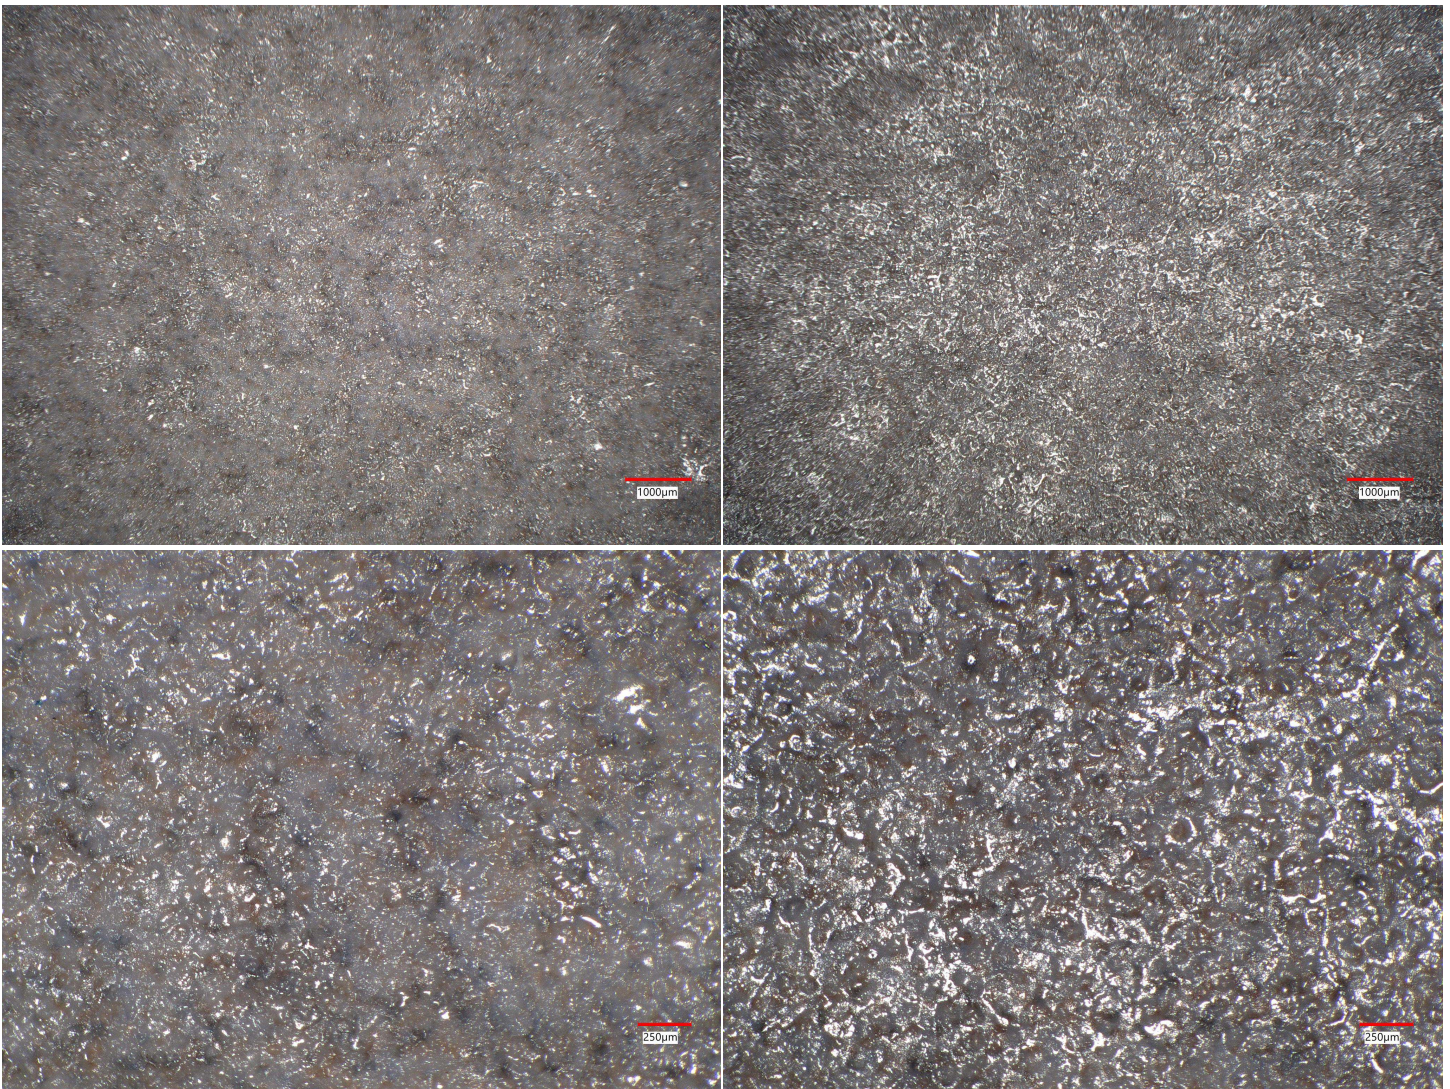
Figure 2. The two images on the left are of the Bad tile sample and those on the right are of the Good tile sample. These images were made with coaxial (through the lens) illumination. The far greater amount of white appearing areas in the right side images shows that the Good tile sample is much more reflective than is the Bad tile sample on the left. Those reflective areas on the left side tend more often to be individually much smaller areas than those on the right side.

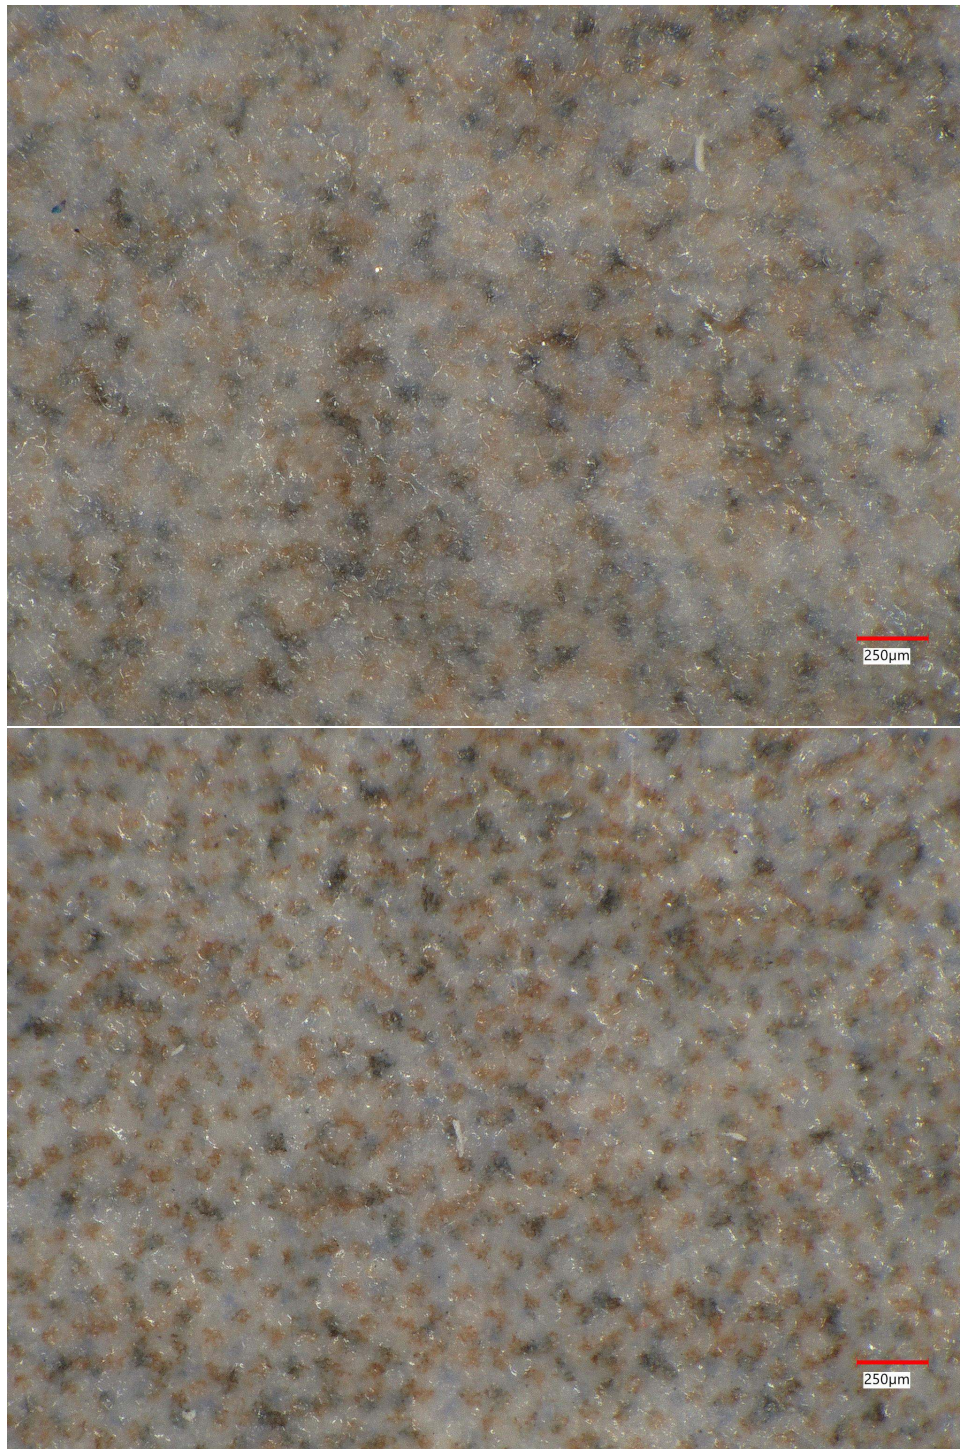
Figure 3. The upper image is of the Bad tile and the lower image is of the Good tile. Both are shown using ring illumination. The translucent glaze on the Good tile appears to be smoother than that on the Bad tile. Notice that the underlying colorant spots are more uniformly seen in the Good tile than in the Bad Tile. This is because the translucent glaze over the colorant is so thick in some areas that its obscures the colorant layer in those thicker glaze areas.

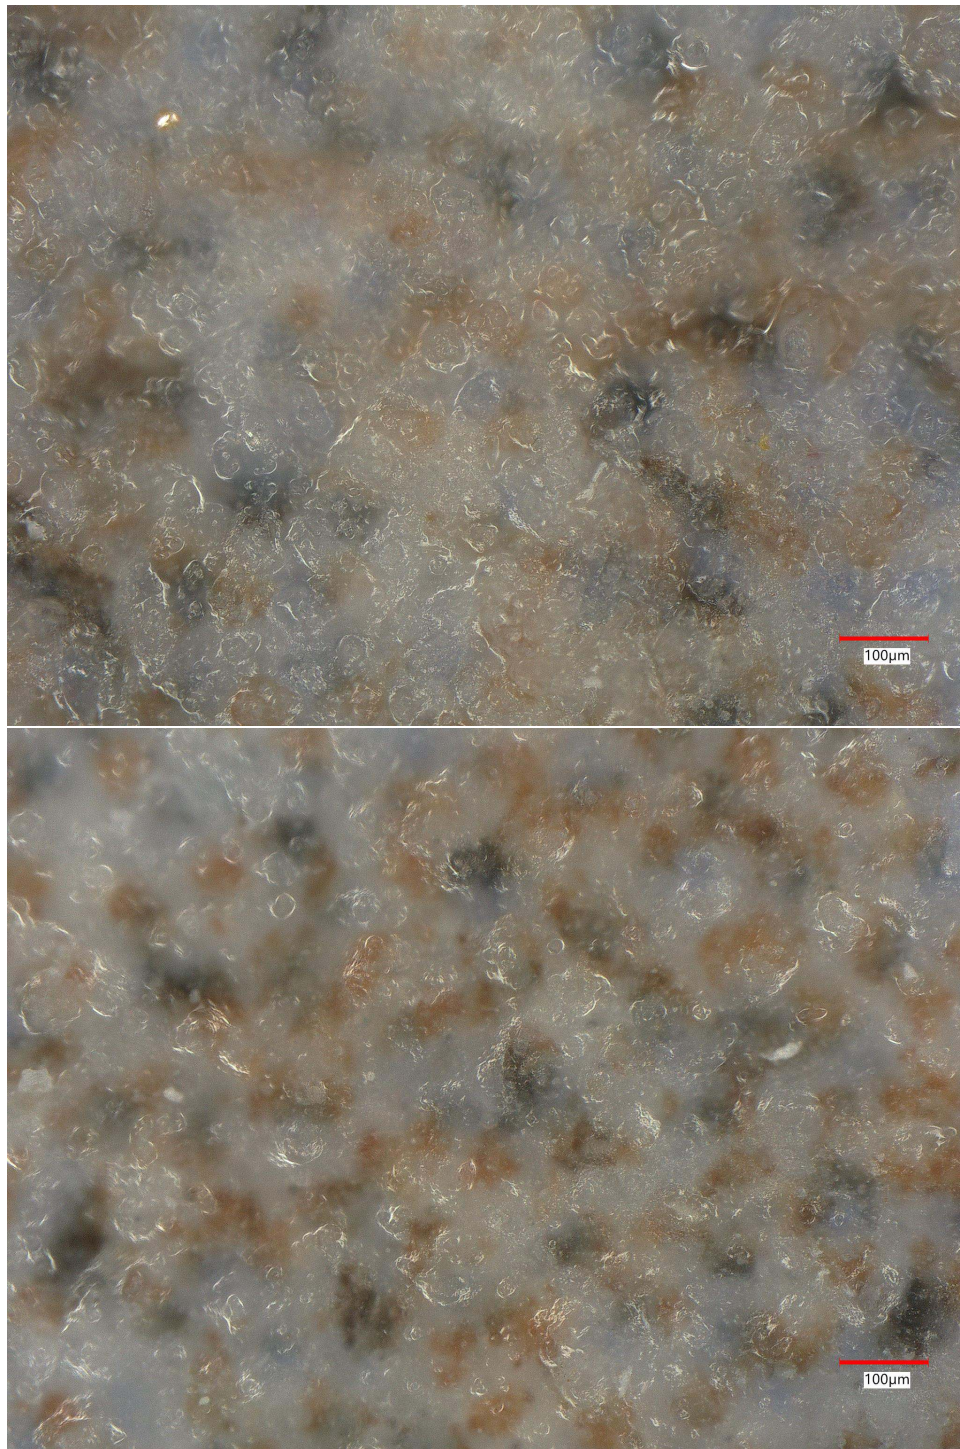
Figure 4. These ring illuminated images of the Bad tile (above) and the Good tile (below) show that the translucent glaze is more evenly applied across the surface of the tile on the Good tile than on the Bad tile. This is indicated by the more uniform visibility of the colorant layer. Note also that there are more featureless areas of the glaze in the Good tile compared to the Bad tile. This indicates a more thorough melting of the glassy powder material that was spread over the surface to form the glaze. The particles before partially melting were spread more uniformly over the Good tile than they were over the Bad tile.

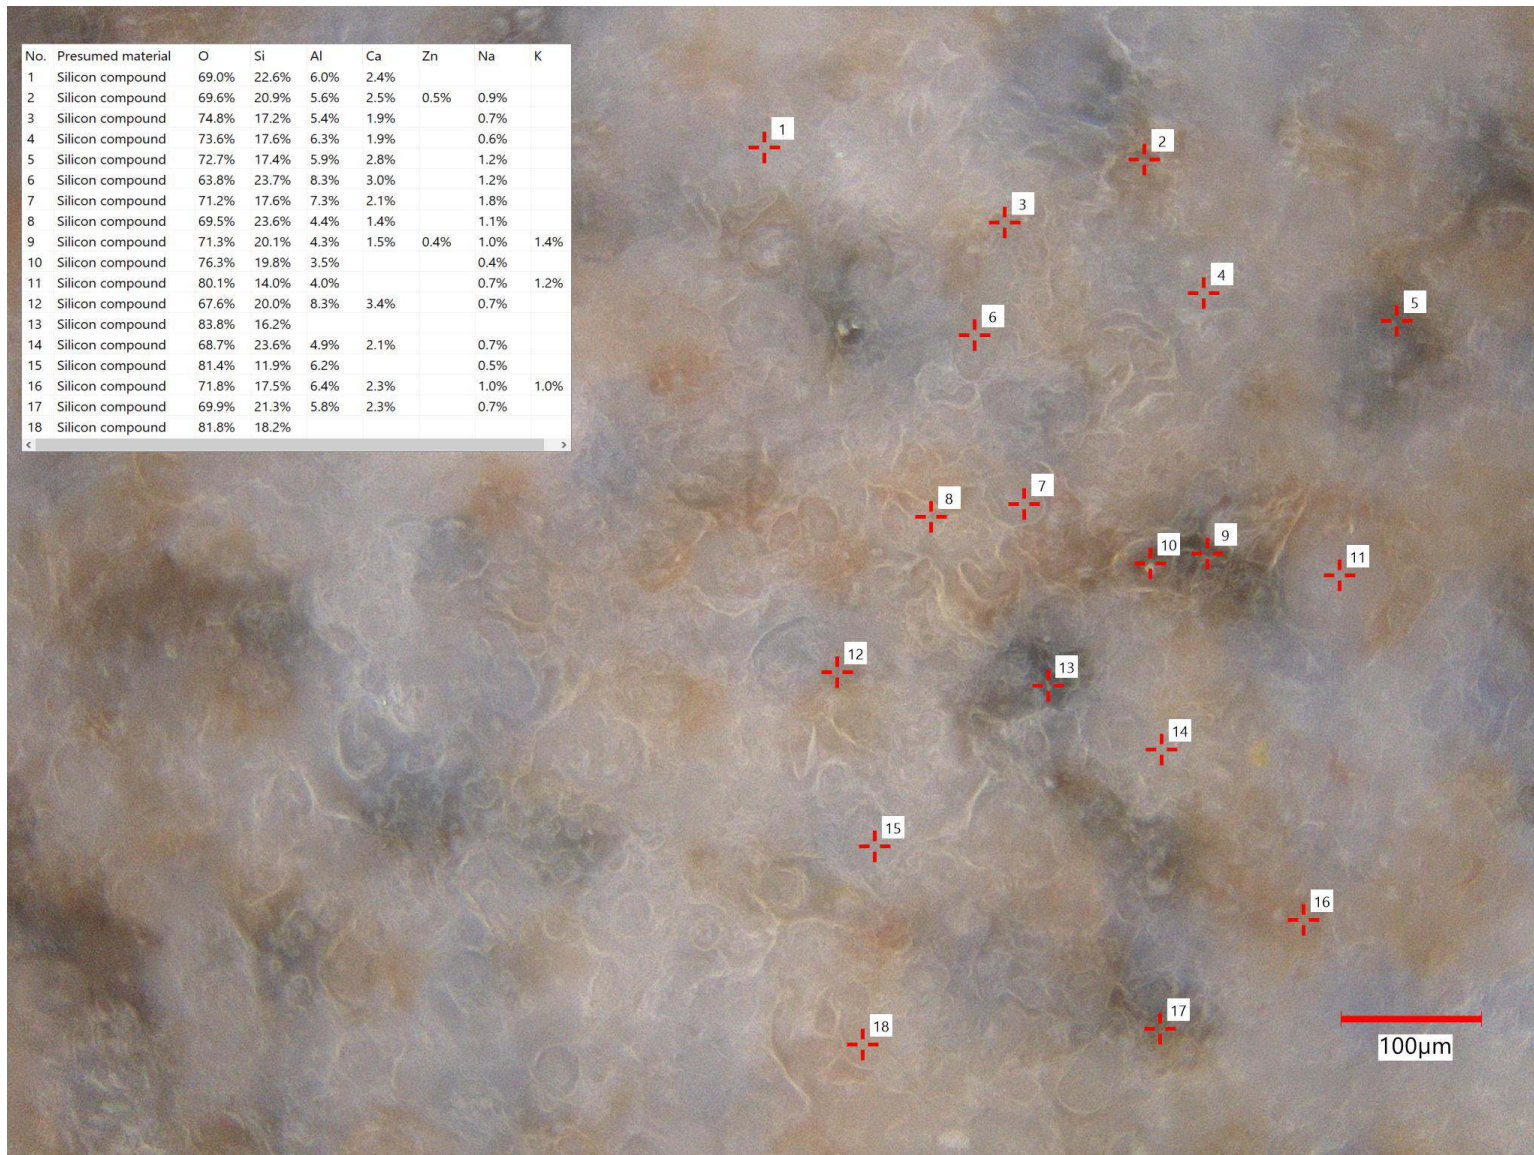
Figure 5. The LIBS analysis of 18 sites on the tile surface are given in atomic percents in the embedded table for the Bad tile. The glaze is mostly an aluminosilicate with calcium, sodium, potassium, and zinc at lower concentrations.

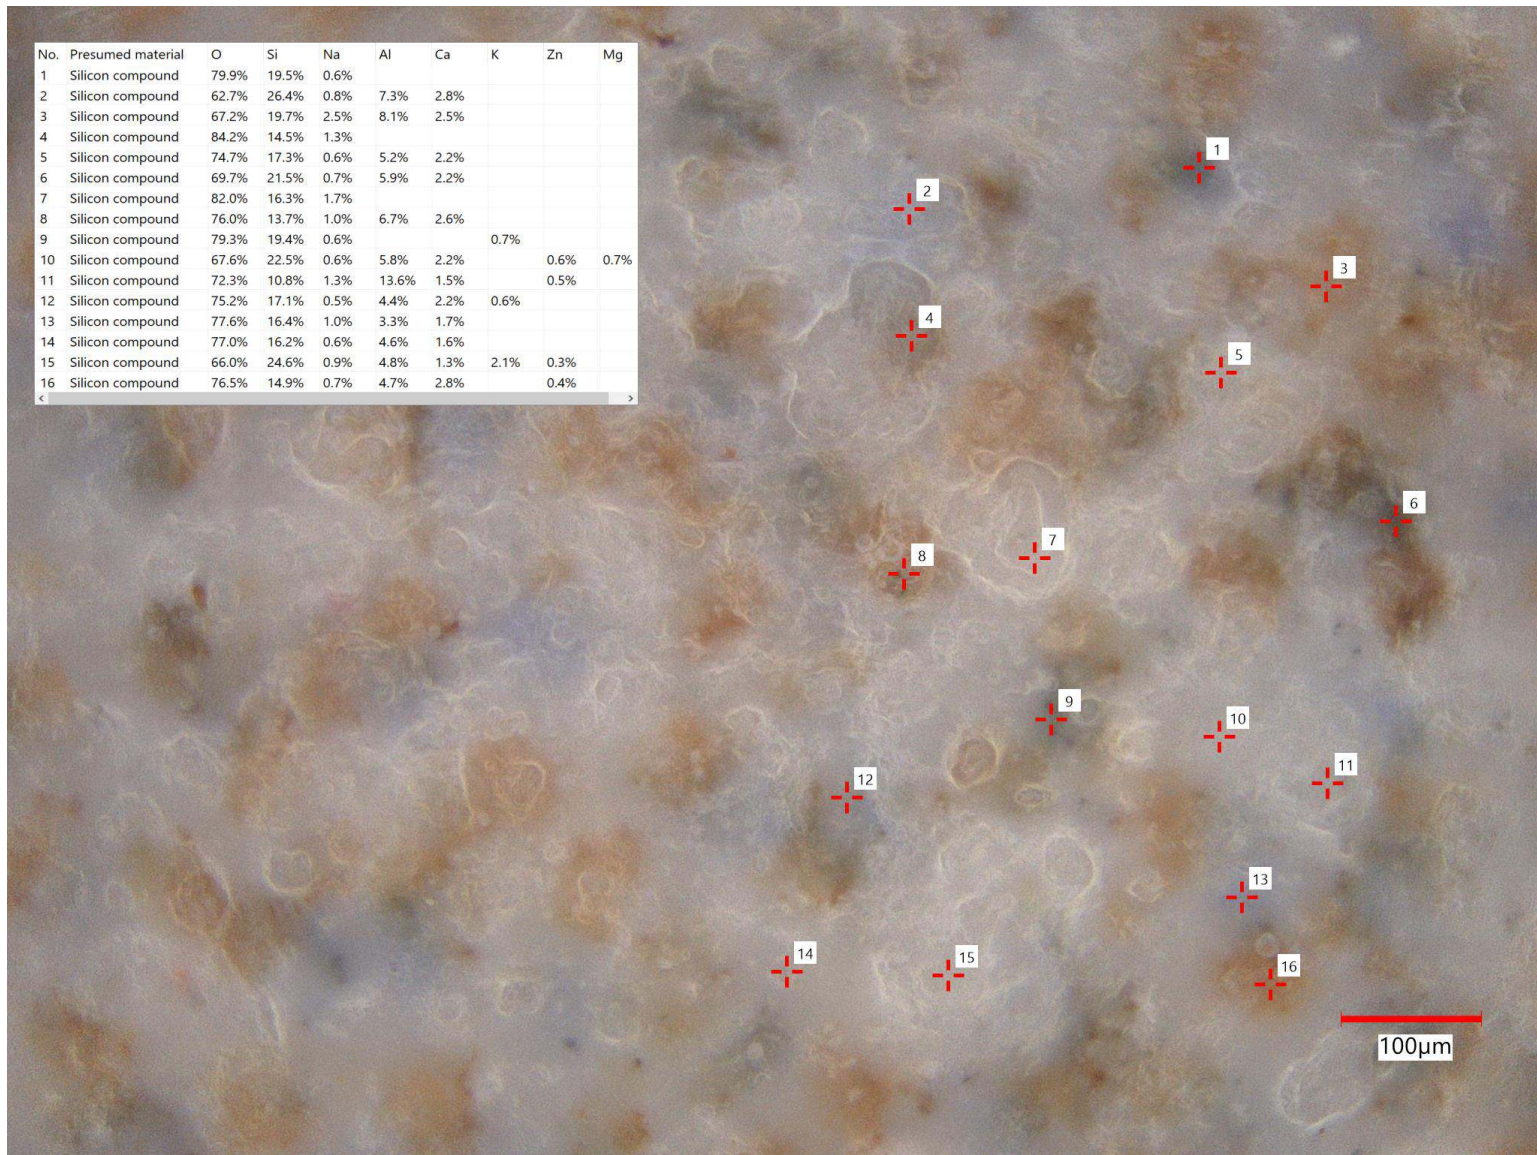
Figure 6. The LIBS analysis of the Good floor tile sample shows that its glaze elemental composition is essentially the same as that on the Bad floor tile. The glaze composition does not seem to be very different between the Good and the Bad floor tiles. The issues seem to be due to its application and the heating to partially melt the powder particles of the silicates.

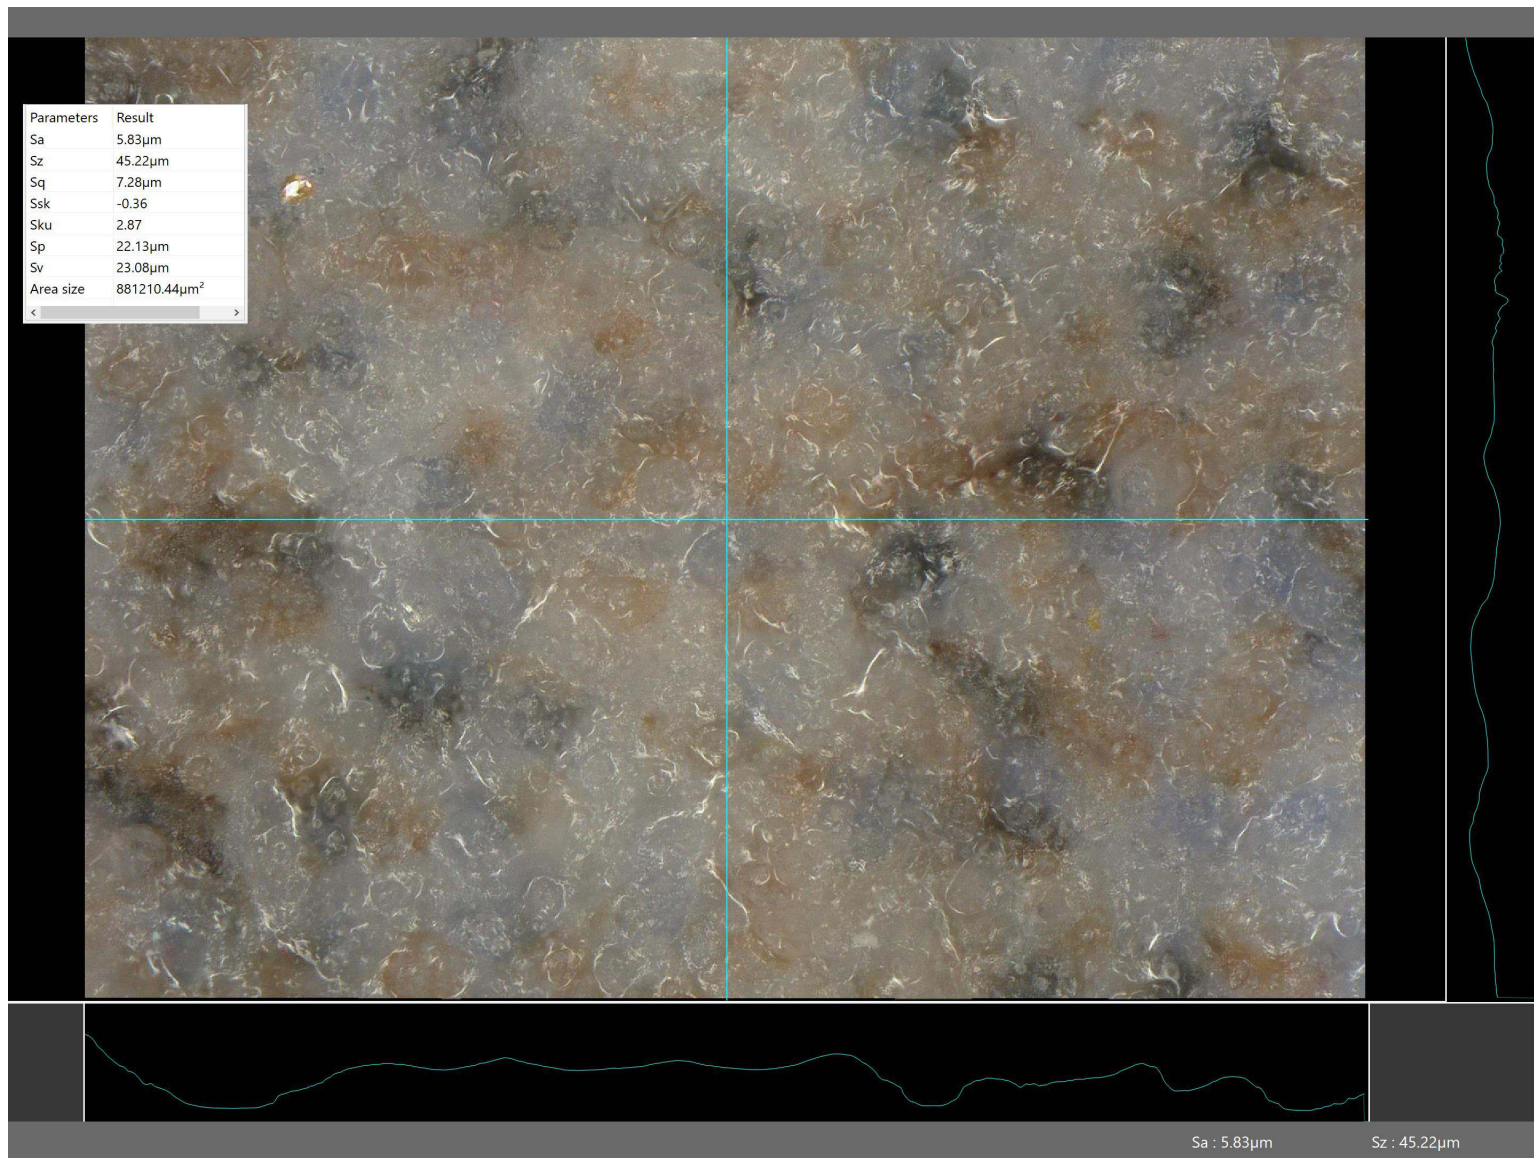
Figure 7. The surface roughness parameters for this area of the Bad tile are shown in the embedded table. The profile along the vertical center line is shown on the right side and the profile along the horizontal center line is shown at the bottom.

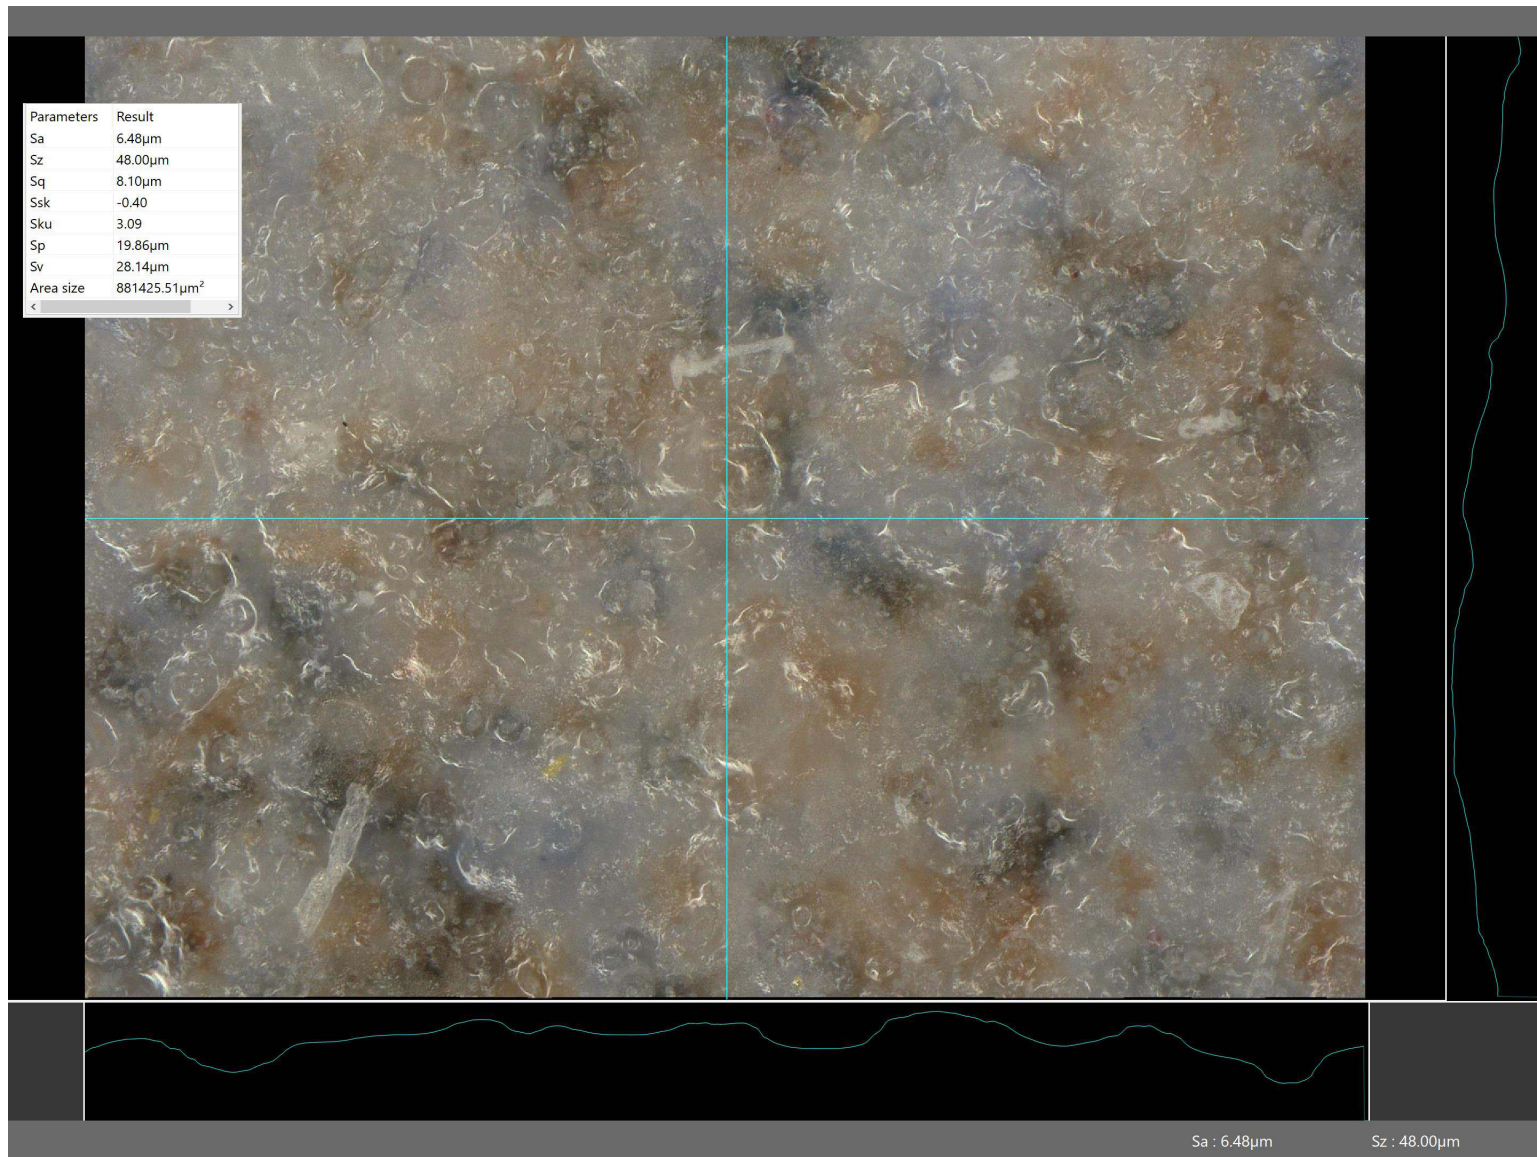
Figure 8. The surface roughness parameters are given in the embedded table for this second area of the Bad floor tile.

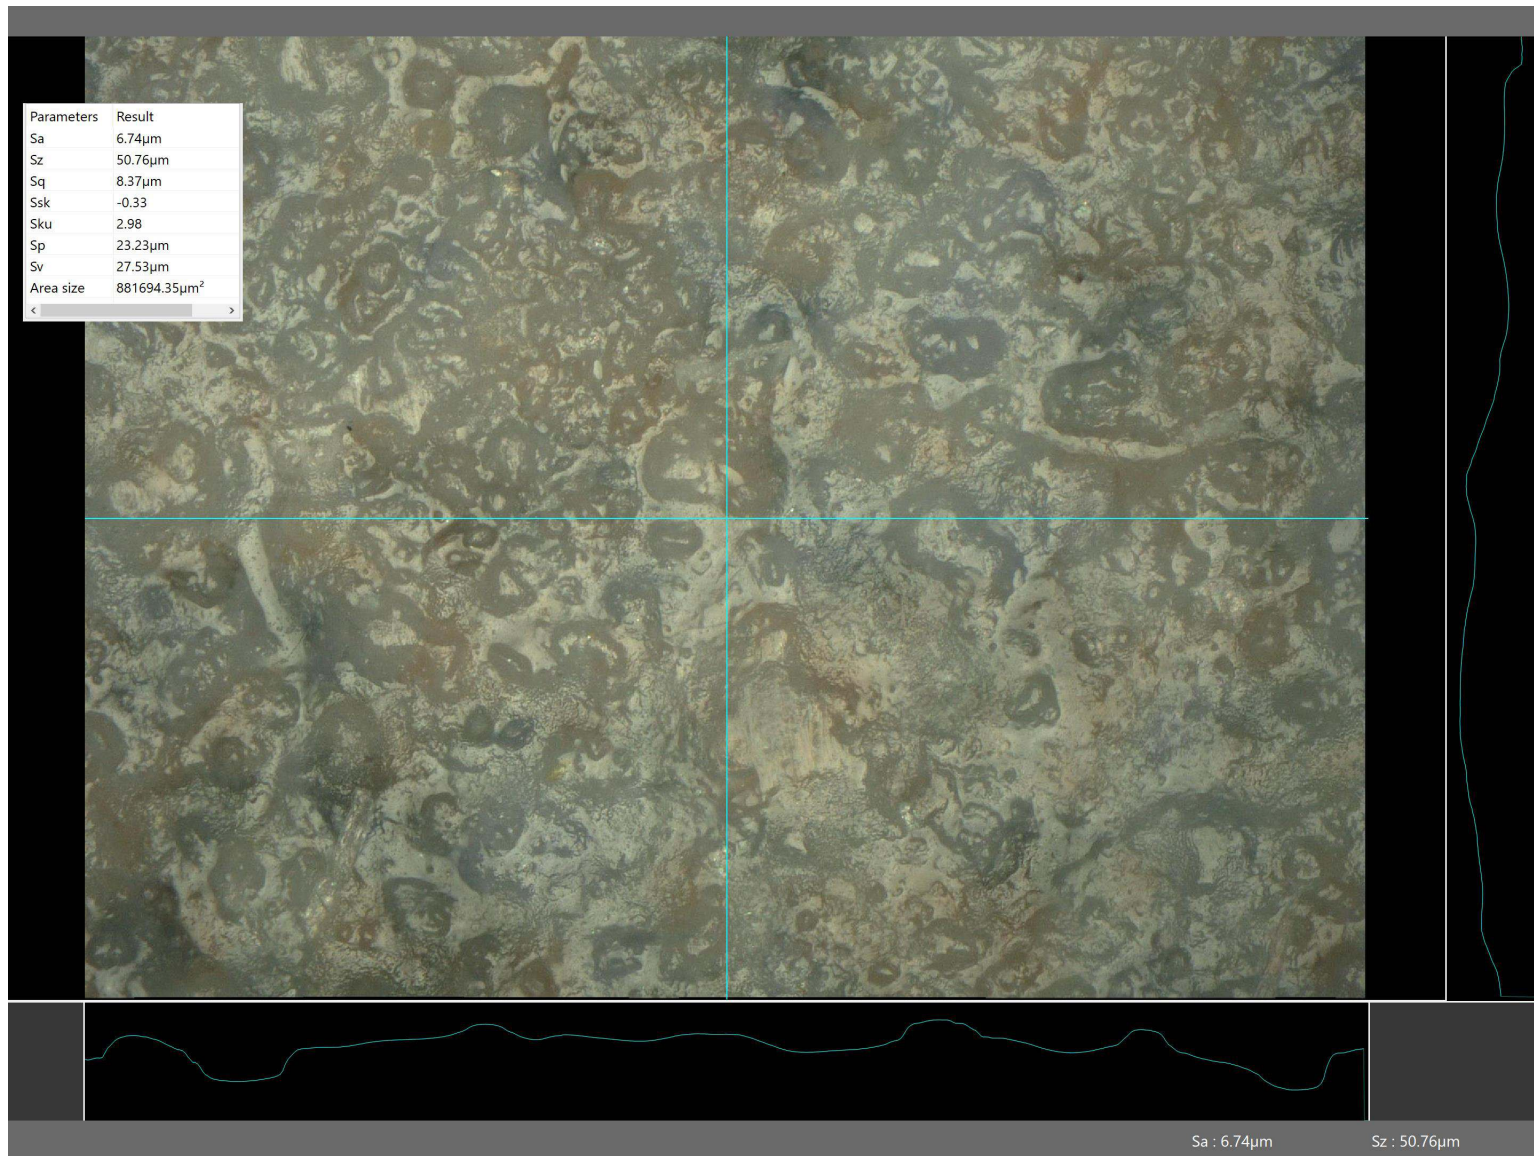
Figure 9. The surface roughness parameters are given for a third area of the Bad floor tile. The illumination is coaxial light, so the reflection off the surface of the glaze is enhanced and the underlying colorants are less visible.

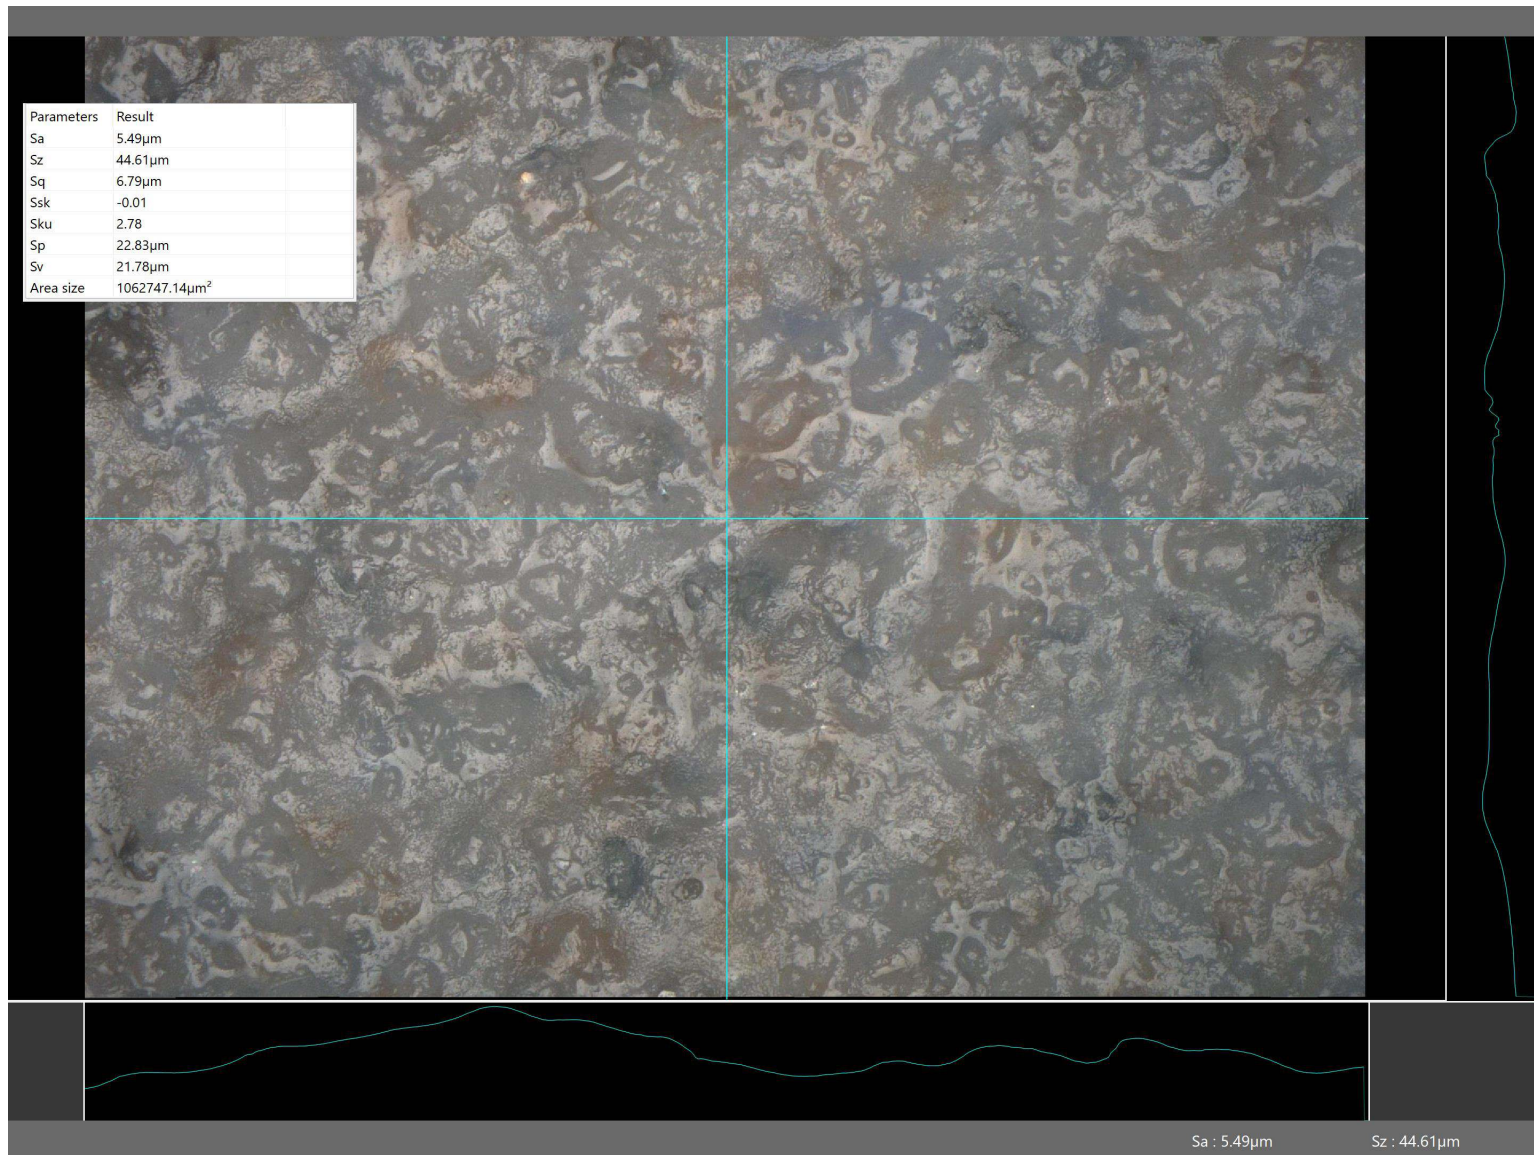
Figure 10. The fourth area examined for the surface roughness parameters for the Bad floor tile is shown above using coaxial illumination.

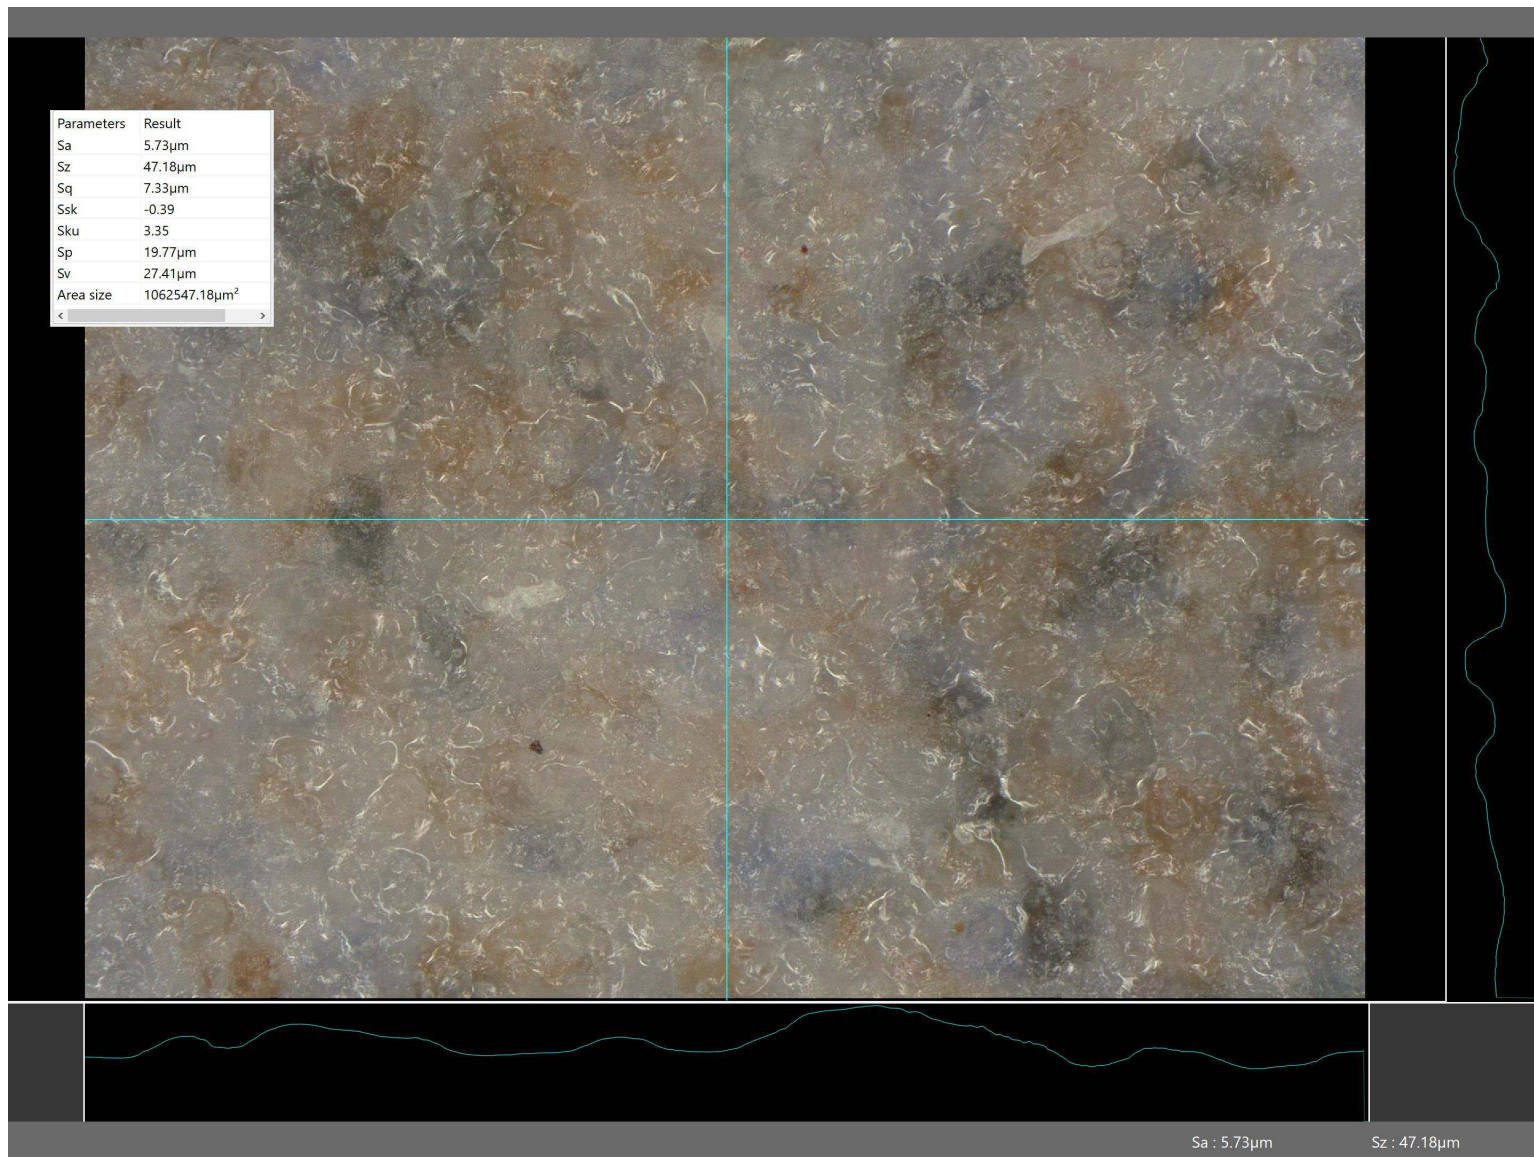
Figure 11. The surface roughness parameters for the fifth area of the Bad tile are given in the embedded table. This image as illuminated by ring lighting.

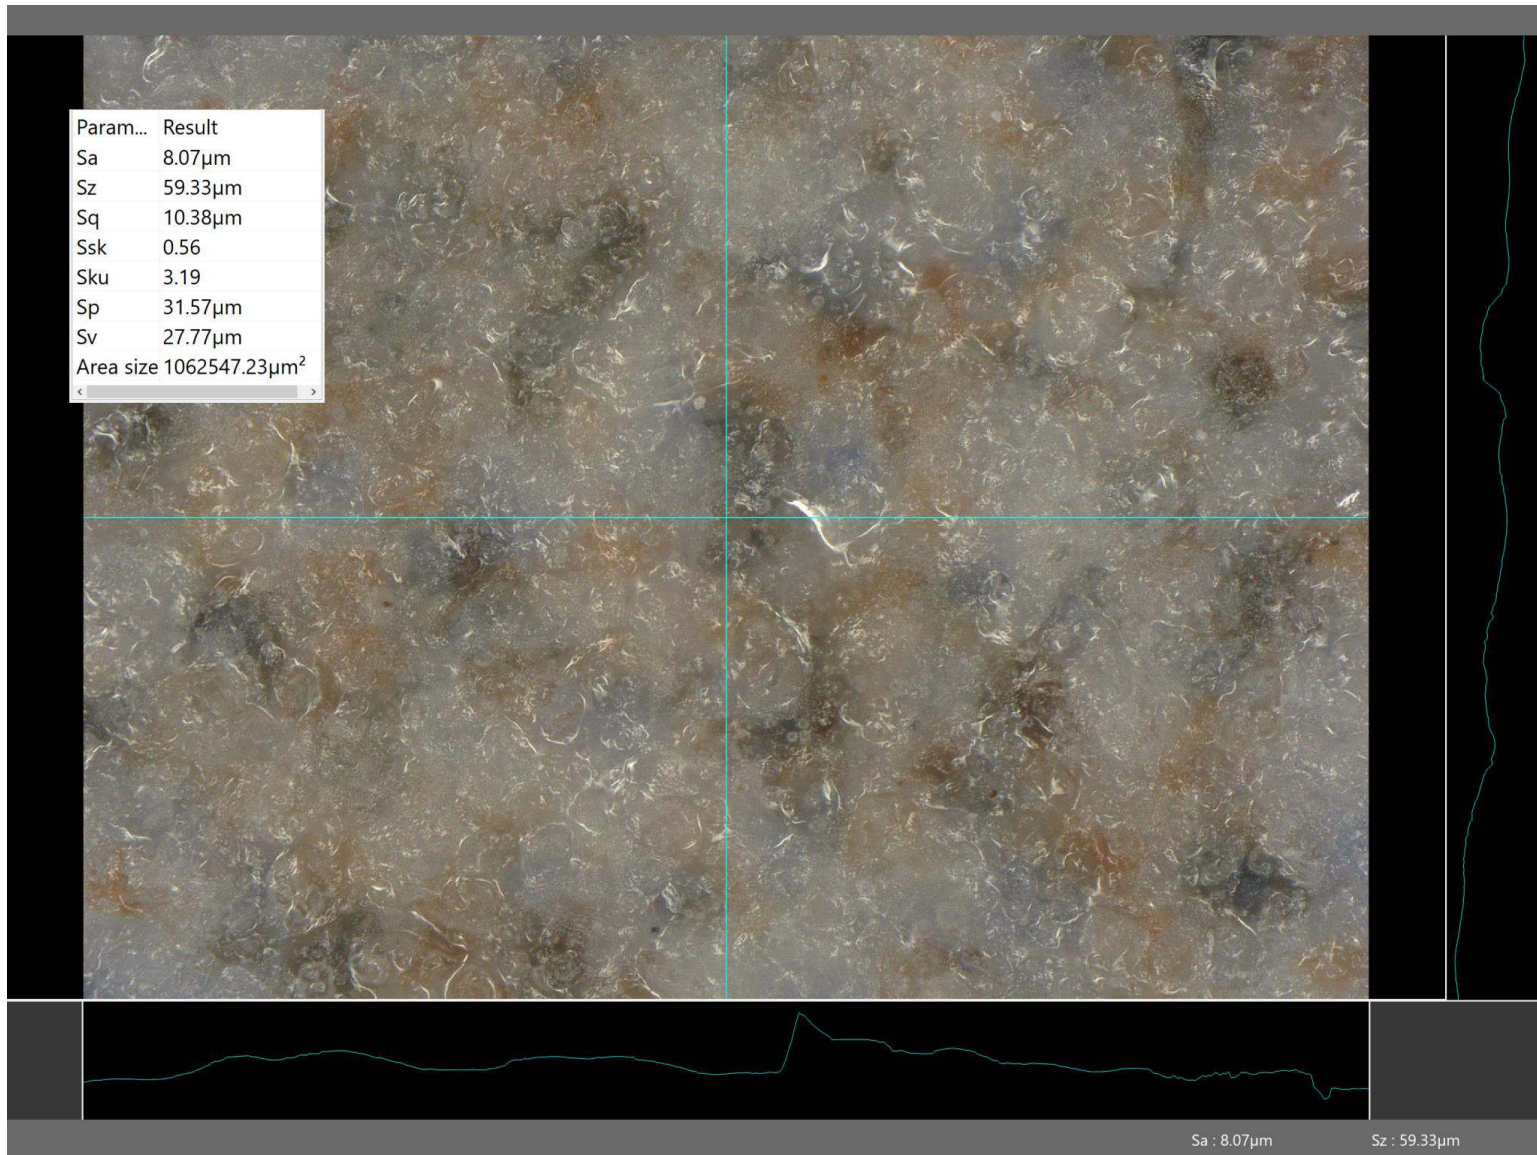
Figure 12. The sixth region of the Bad floor tile for which the surface roughness parameters have been determined.

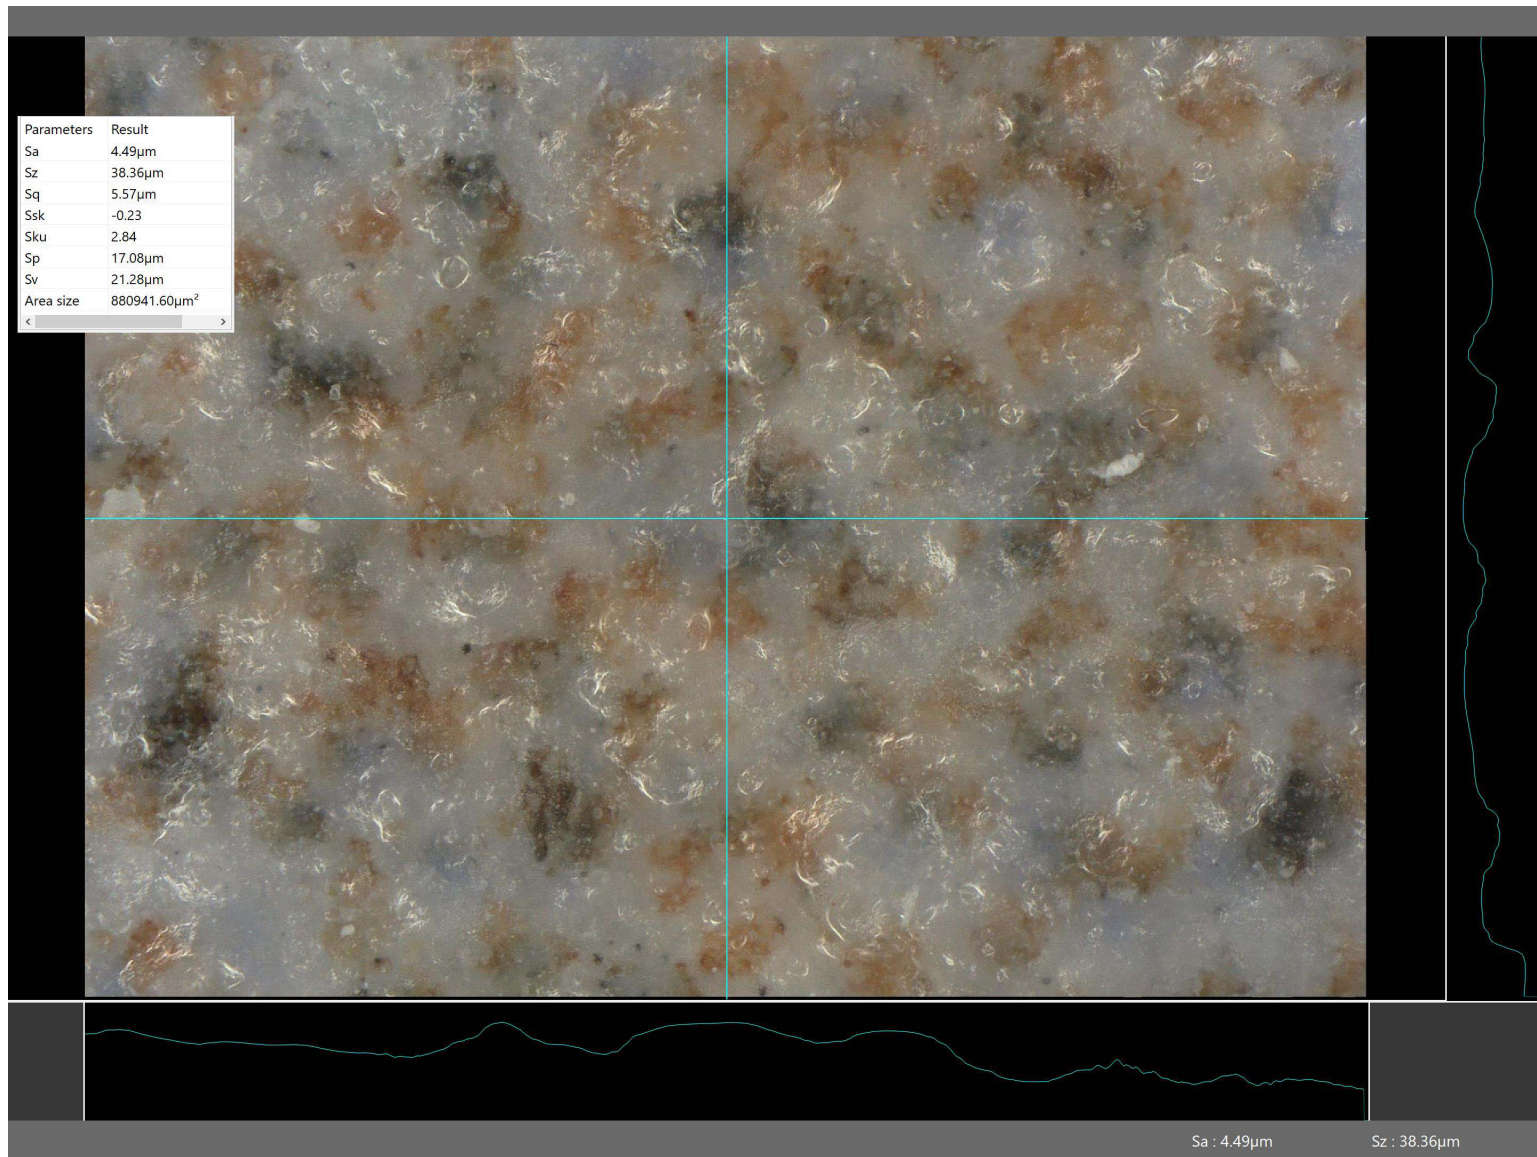
Figure 13. The surface roughness parameters were determined for this area of the Good floor tile.
