# Anderson Materials Evaluation, Inc.

DATE 24 March 2024

SUBJ Analysis of MS International, Inc. Cementino Gray Matte Porcelain Floor Tile Samples Described as Good (Lot 230710) and Bad (Lot 230709) using 3D Optical Microscopy, Profilometry, and Laser-Induced Breakdown Spectroscopy (LIBS)

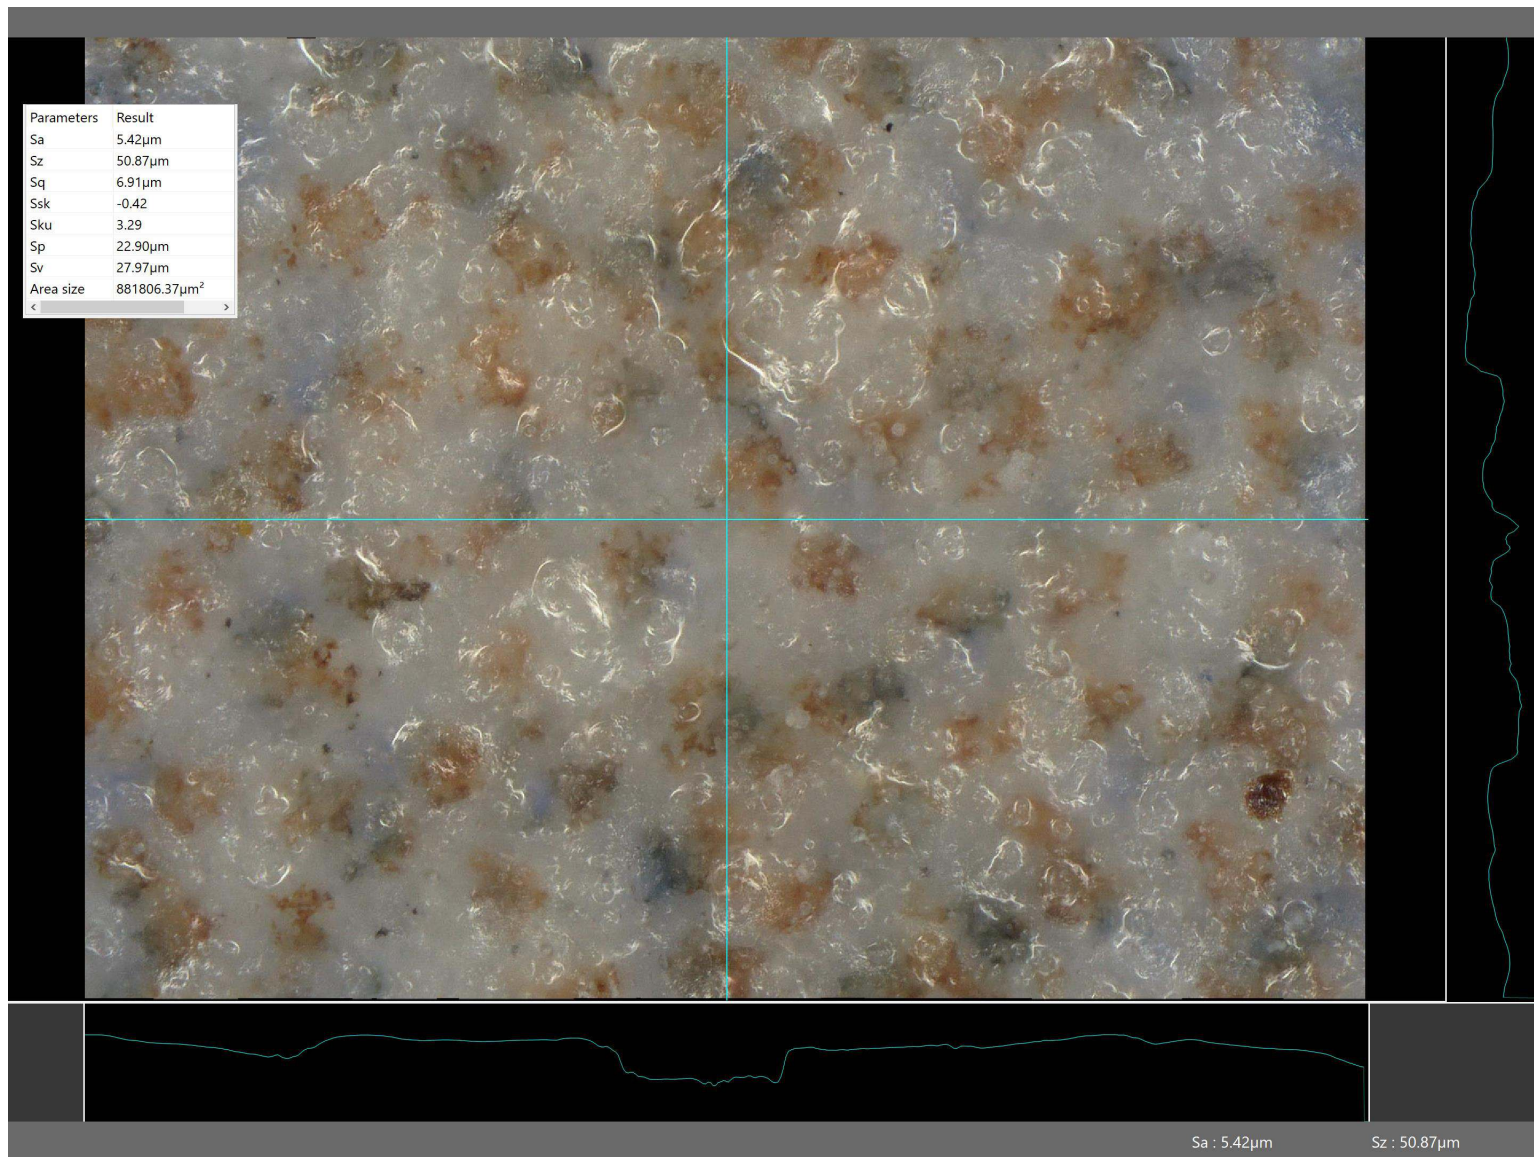
Figure 14. The surface roughness measurements were determined for this second area of the Good floor tile.

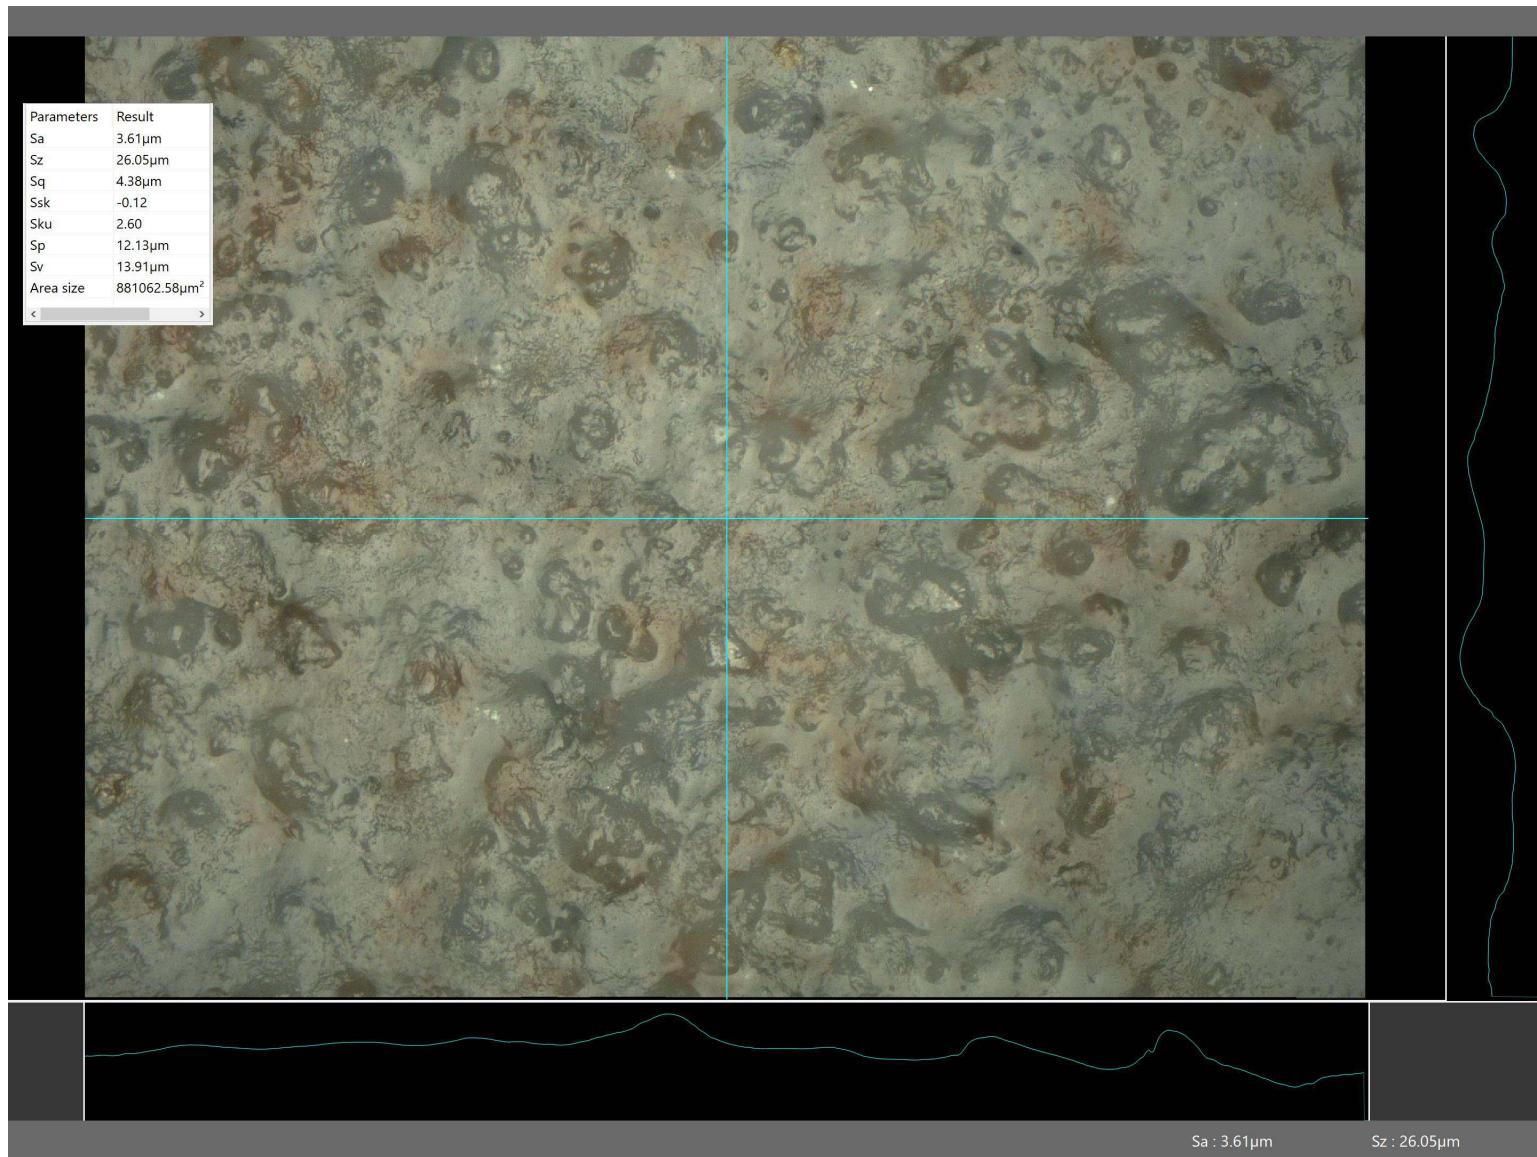
Figure 15. This coaxially illuminated third area of the Good floor tile has the much lower surface roughness parameters given in the embedded table.

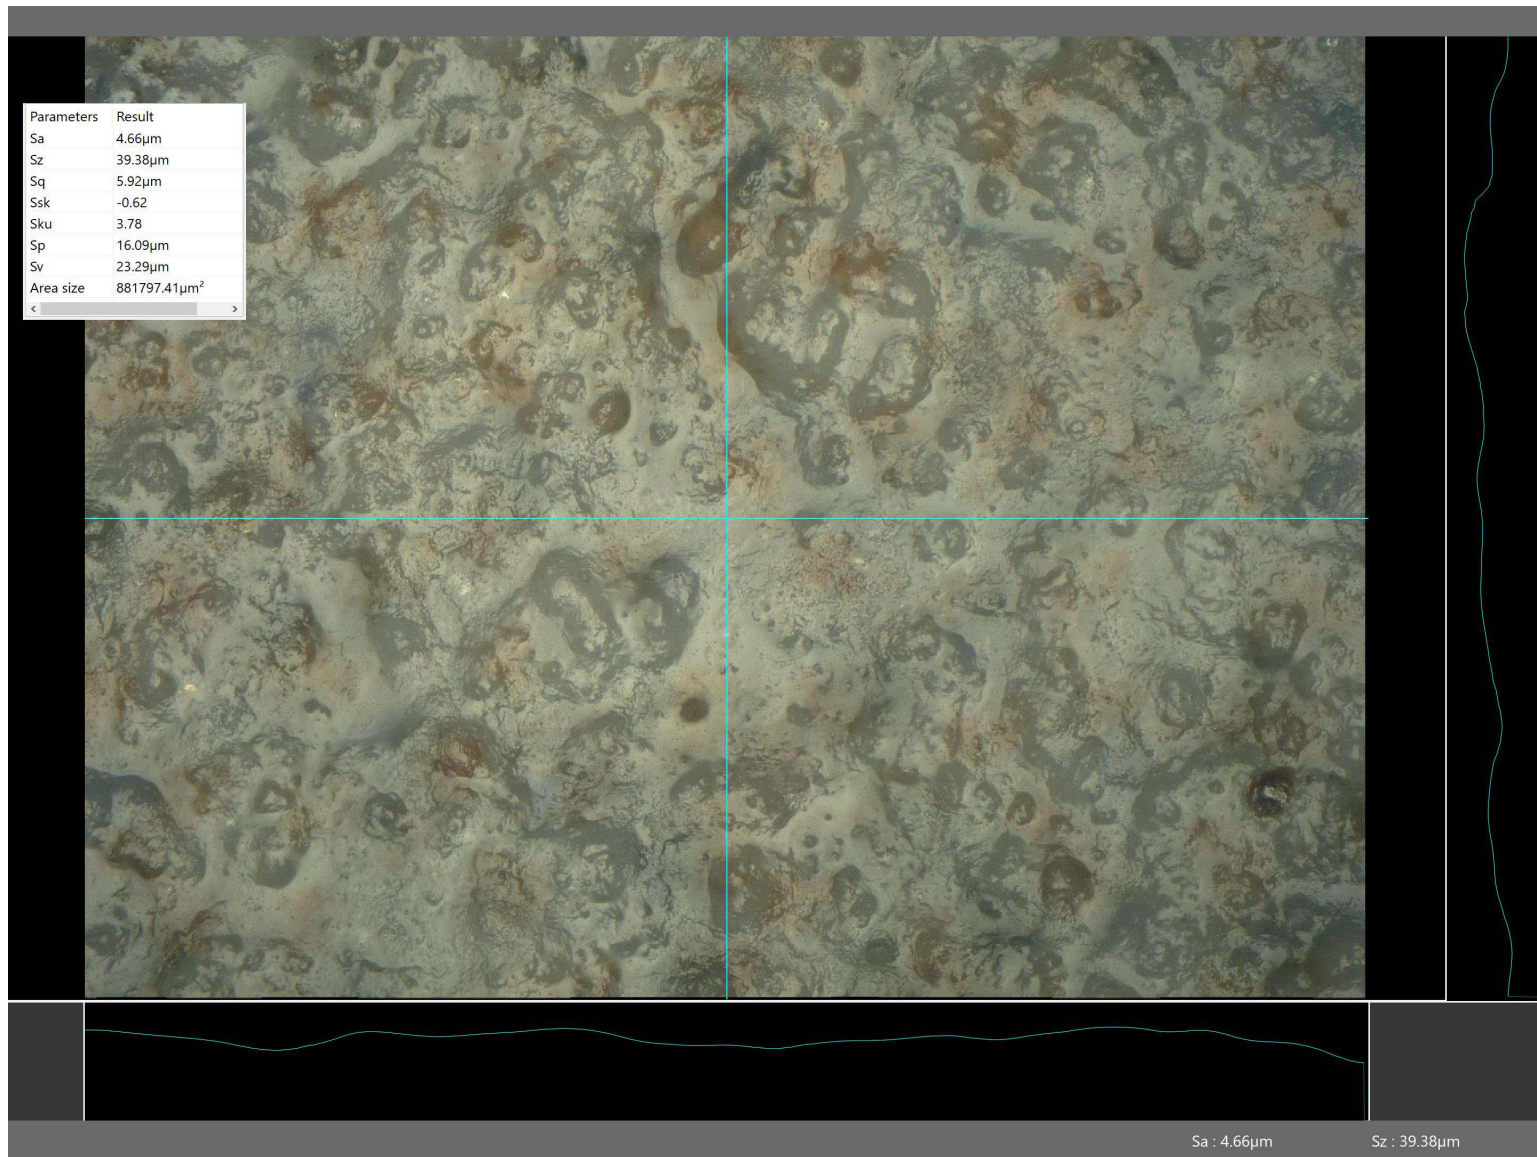
Figure 16. This illumination here is again coaxial. This fourth area of the Good floor tile has the surface roughness measurements given in the embedded table.

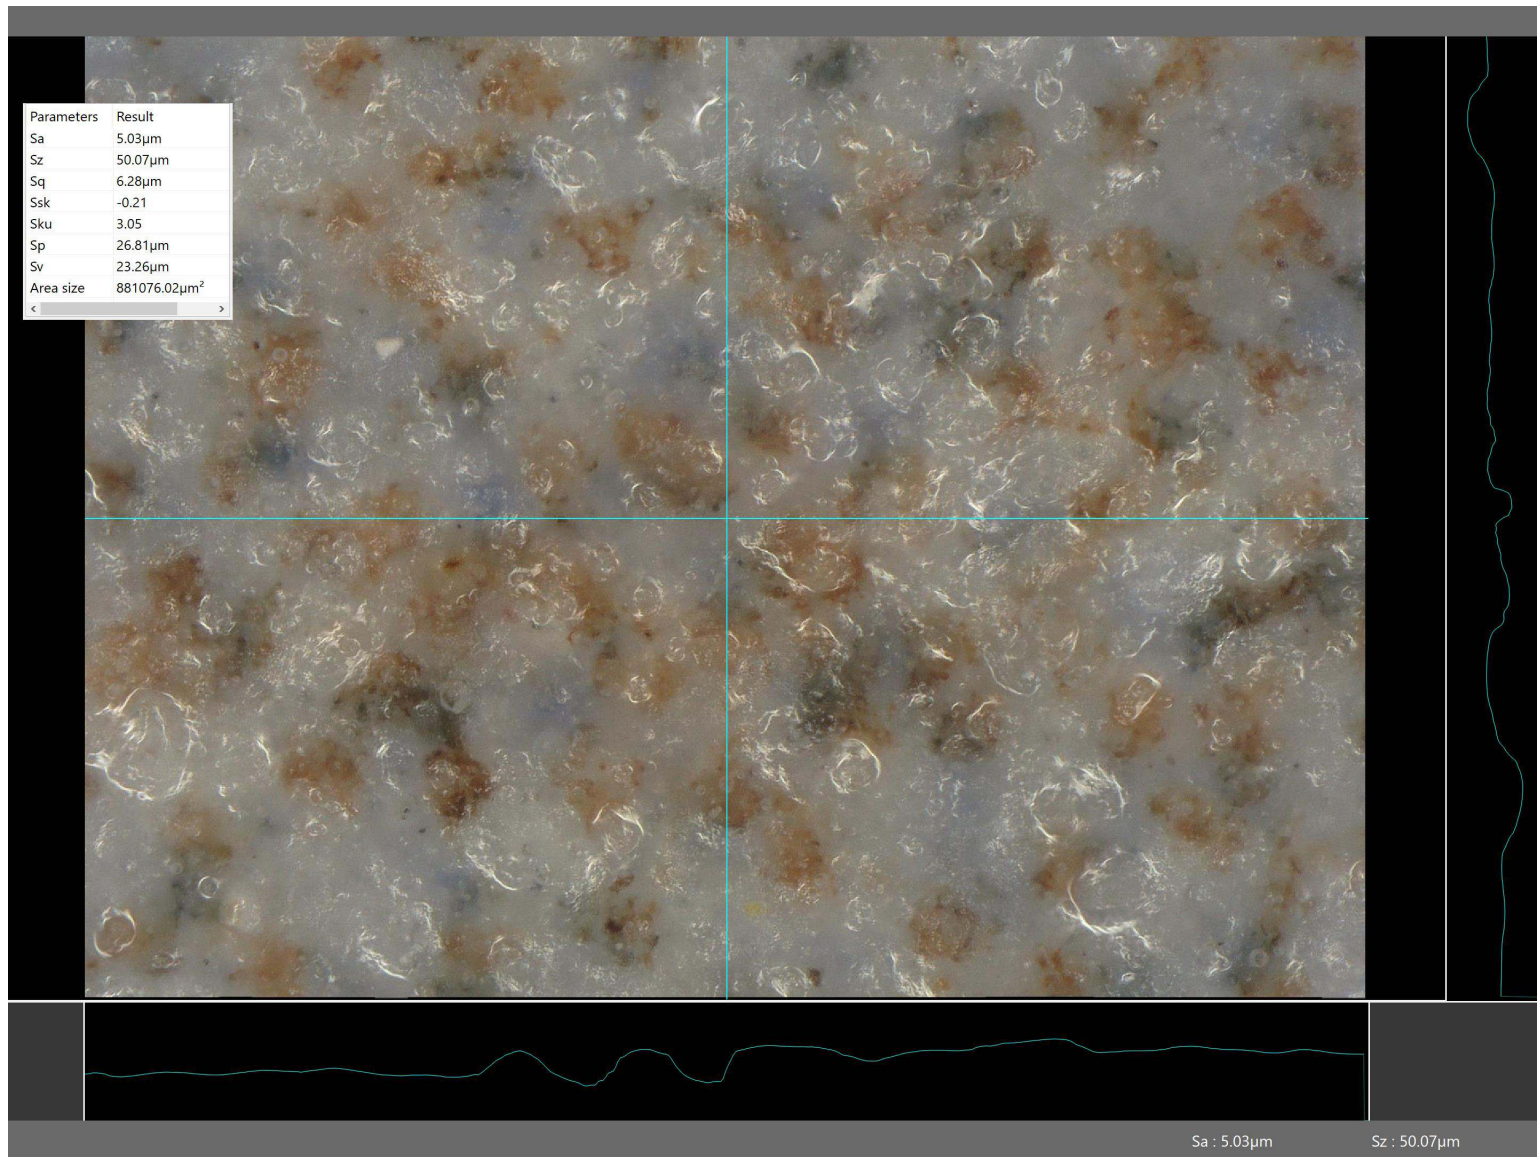
Figure 17. This is the fifth area of the Good tile with its surface roughness parameters.

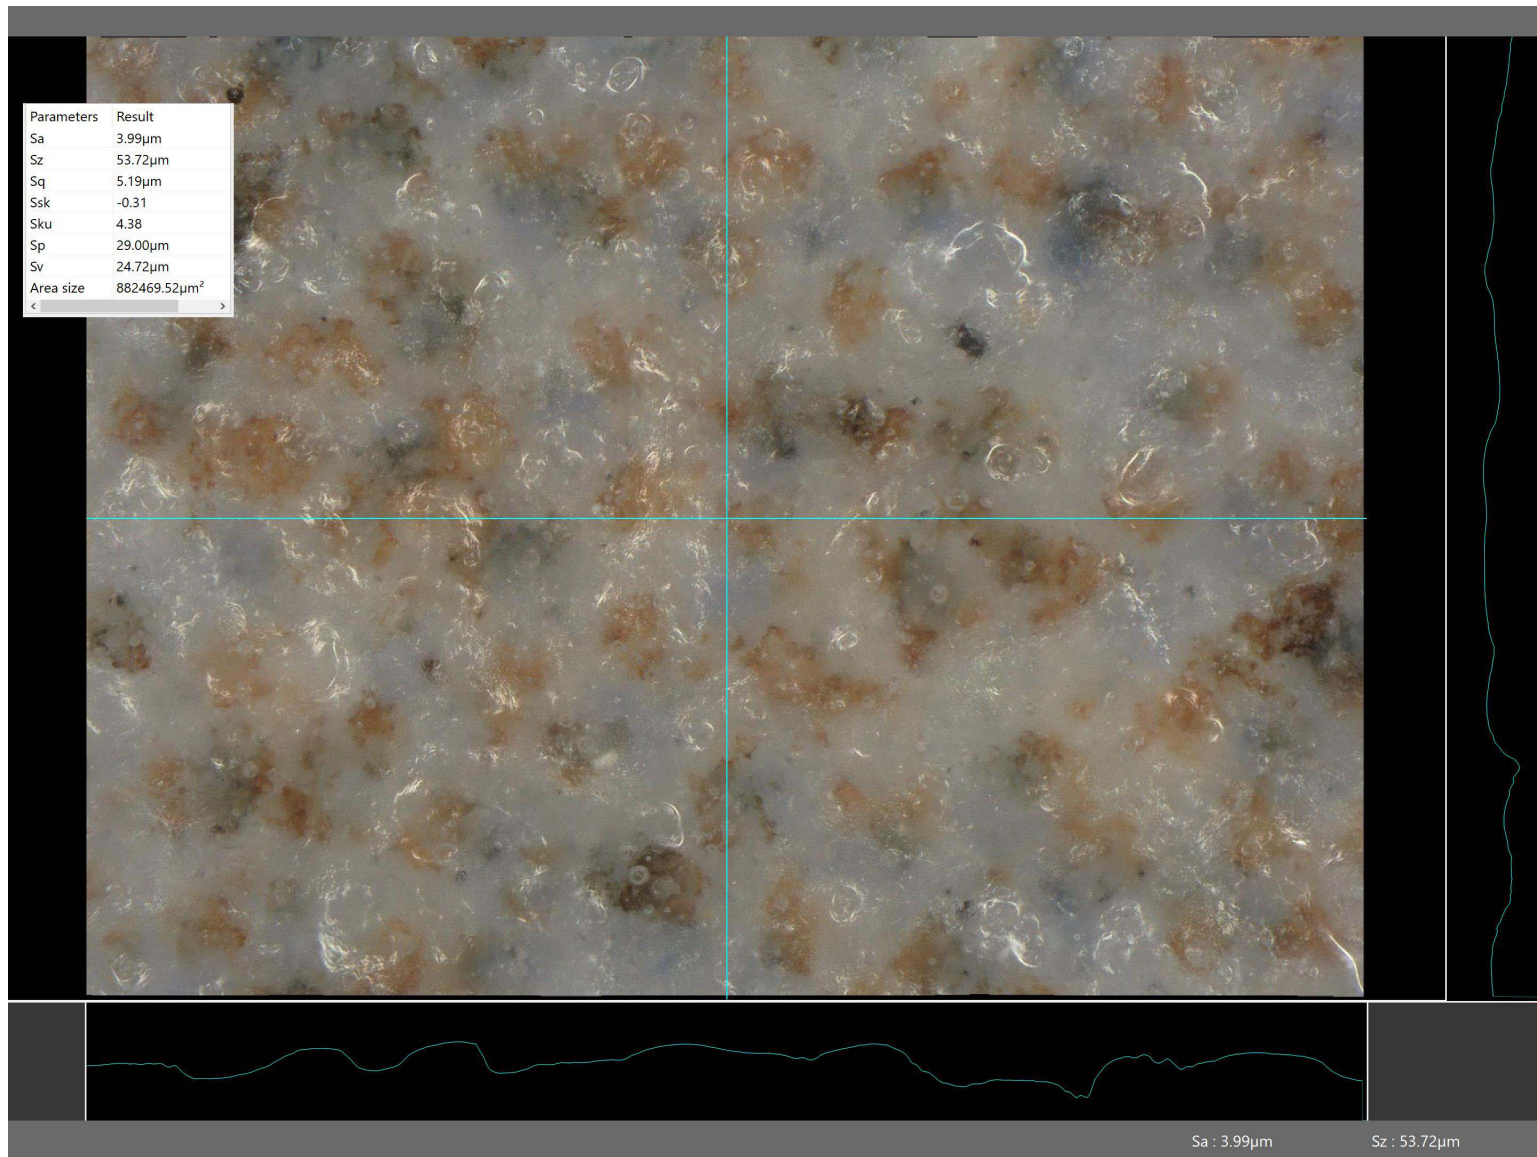
Figure 18. This sixth area of the Good tile has the surface roughness parameters given in the embedded table.
