# Anderson Materials Evaluation, Inc.

SUBJ XRF analysis of Lumber Samples to Detect Copper from Preservative Treatments

## **Summary**

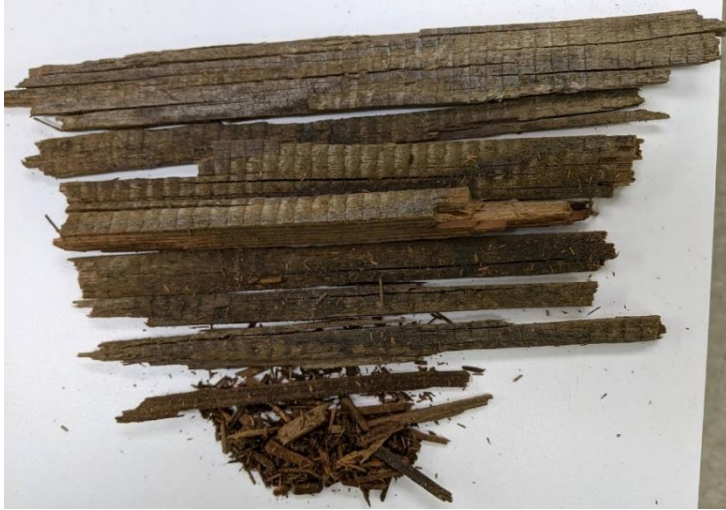
Figure 1. The disintegrating wood received from the surfaces of the bridge wood.

Wood samples identified as from the surfaces of rotting wood from a bridge were sent for analysis for a wood preservative. See Figure 1 for a picture of the wood samples we received for analysis. Figure 2 shows the samples which were actually analyzed by XRF with the surface facing the x-ray source and detector shown.

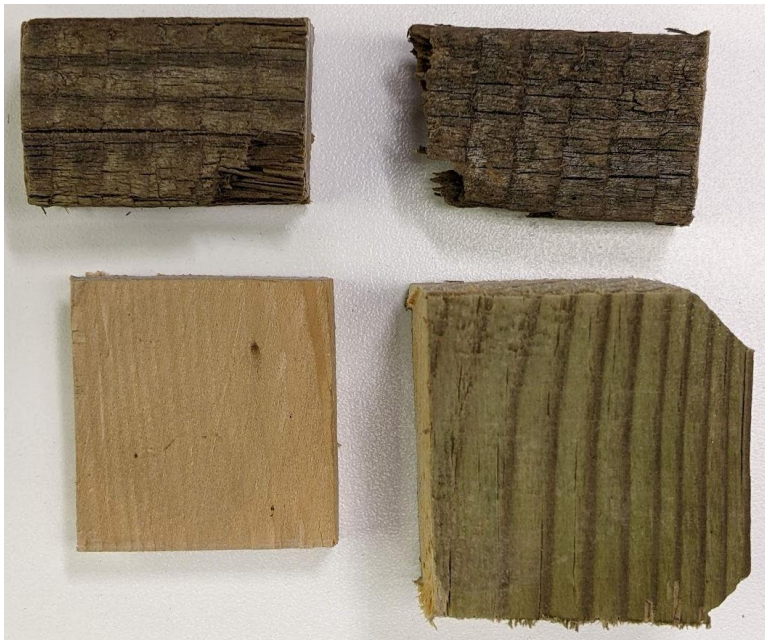
Figure 2. The two samples taken from the submitted bridge wood sample material which were analyzed by XRF are shown at the top of this picture. The cedar wood sample is at the lower left and the known pressure treated preservative wood sample with the slightly green surface color is shown in the lower right of the picture.
